Level 2, Premium Reserve Analysis

Tallyn's Reach Metro District

24900 E. Park Crescent Dr.
Aurora, CO. 80016

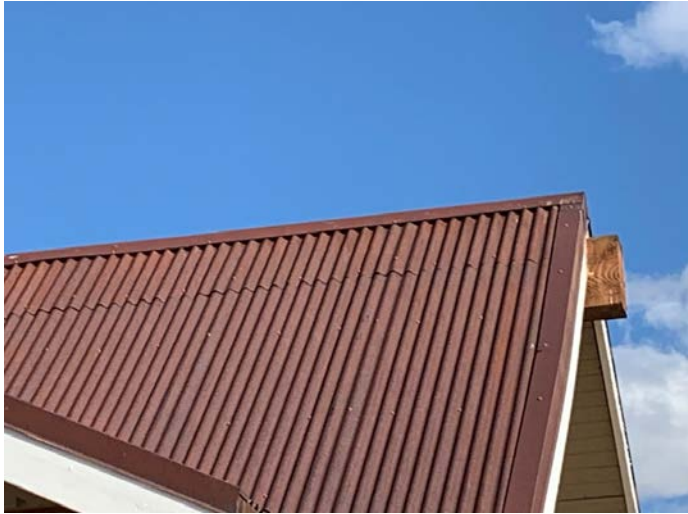
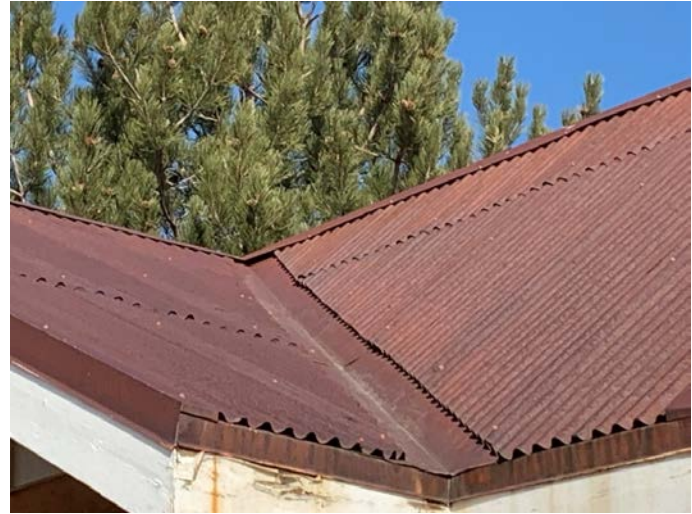
Comp #: 108 Metal Roof - Replace

- Roofs should be inspected at least every 2 years to ensure seams and screw holes are caulked properly and there are no areas where water intrusion can occur.
- The main concern for damage is from dents and dings as a result of hail.
- On average, expect to replace this roof every 20 - 25 years under normal conditions.

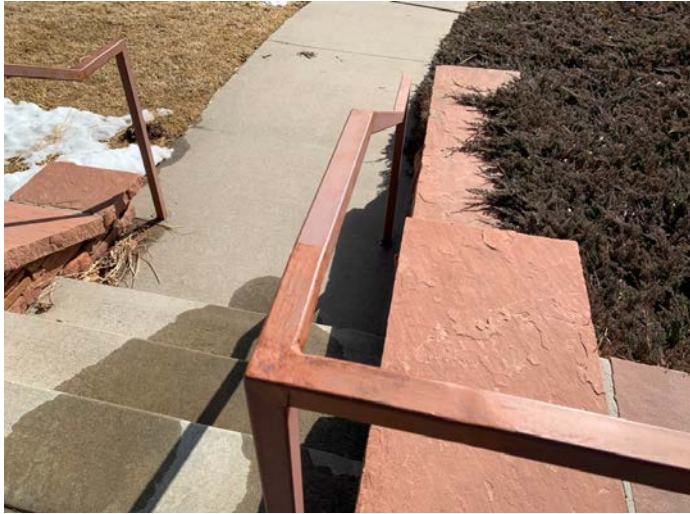
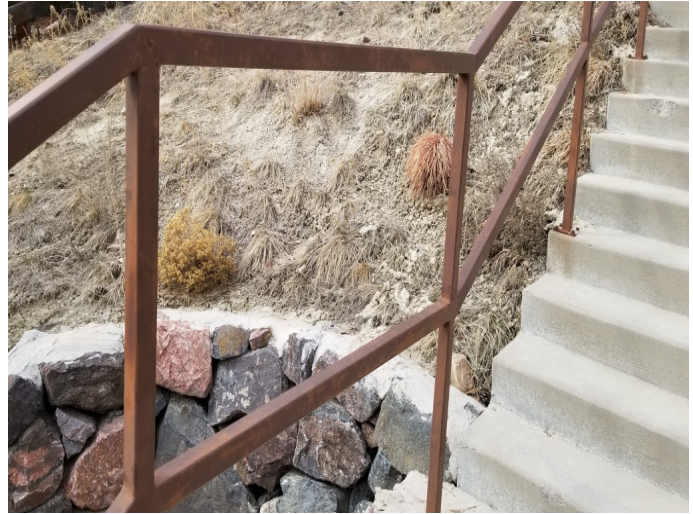
Comp #: 207 Exterior Metal Surfaces - Repaint

- In this climate, we recommend repainting this component every 3 - 4 years to maintain appearance and protect metal surfaces.
- Remaining life based on current condition.

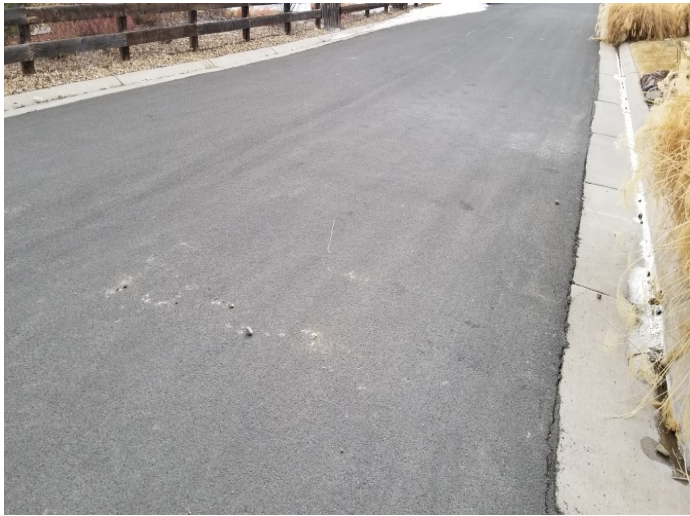
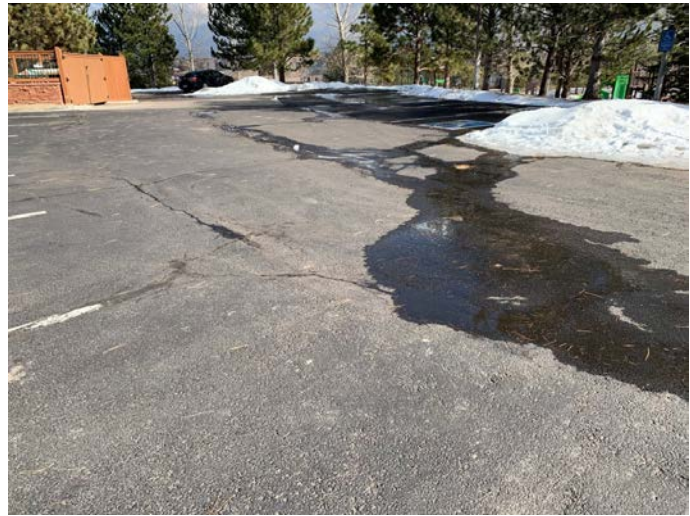
Comp #: 401 Asphalt - Major Overlay

- The average life expectancy for asphalt surfaces ranges between 20 - 27 years for surfaces that are maintained on a regular schedule.
- Maintenance includes crack fill and repairing small potholes annually as an operating expense.
- In addition, asphalt should be seal coated every 3 - 5 years, depending on the level of traffic and snow removing techniques.

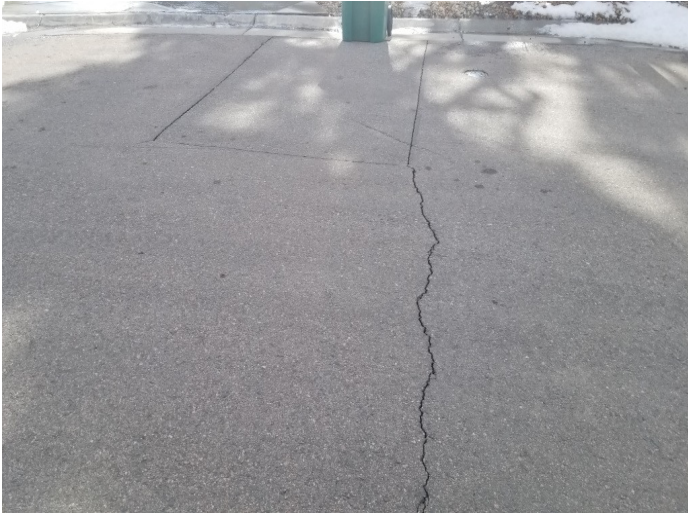
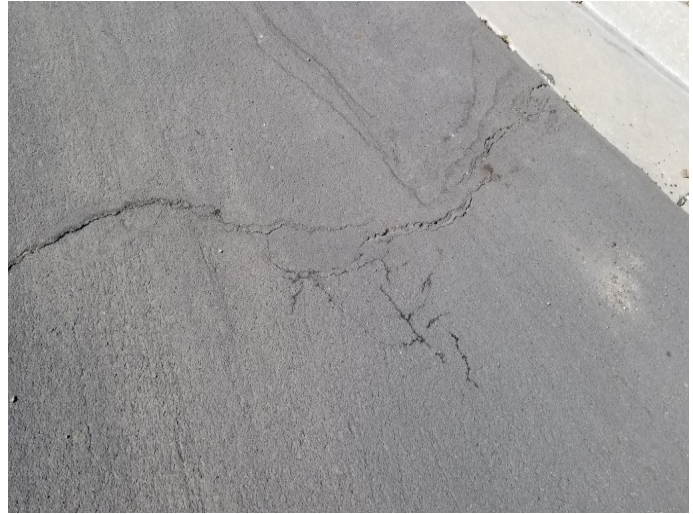
Comp #: 402 Asphalt - Surface Application

- Once asphalt is overlaid, industry professionals recommend a seal coat to maximize life of asphalt.
- Surface treatments are used to extend the useful life of asphalt and to help maintain aesthetics; there are a broad range of products to choose from so we recommend consulting a reputable contractor for your community's needs.
- The recommendation is an allowance for the mid range surface treatments that are available in today's market.
- Expect to seal coat, chip seal or slurry seal your asphalt every 4 - 5 years, as the asphalt ages it may be necessary to adjust the frequency and or cost of these projects.

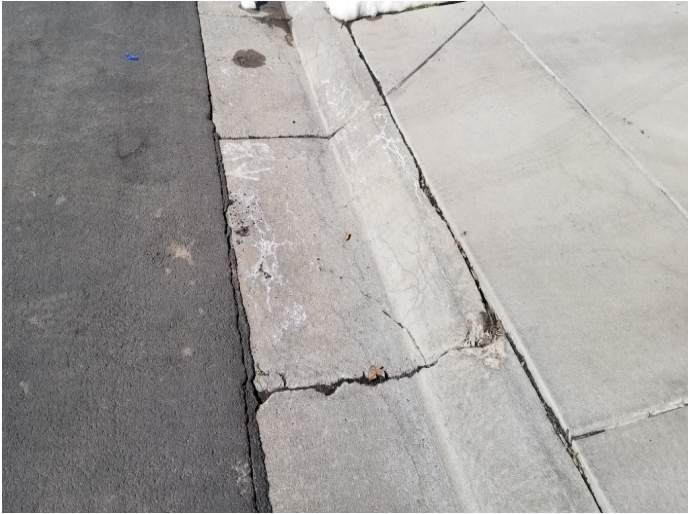
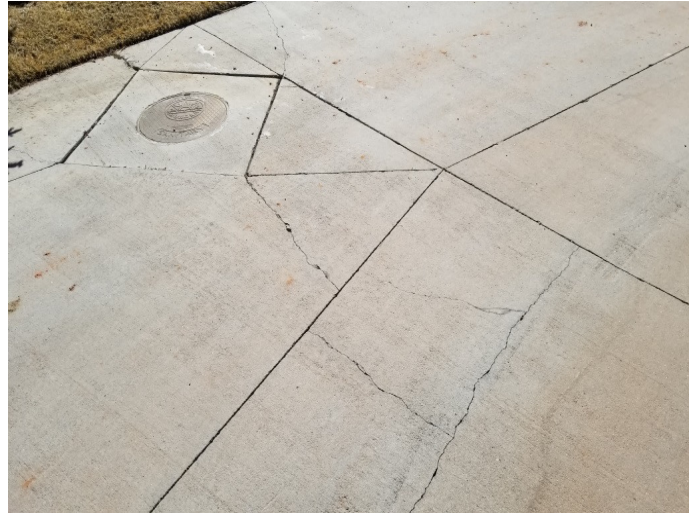
Comp #: 403 Drive Concrete - Major Repair/Partial Replace

- It is unlikely that all concrete will fail and need to be replaced at the same time, therefore, we recommend reserving to replace approximately 10% of the area (5,360 GSF) every 5 years.
- Coordinate this project with other concrete and/or asphalt projects for best cost estimates based on quantity of work.

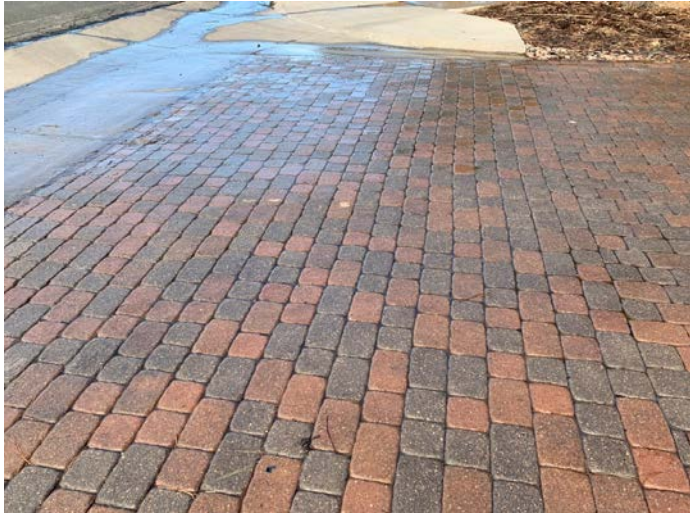
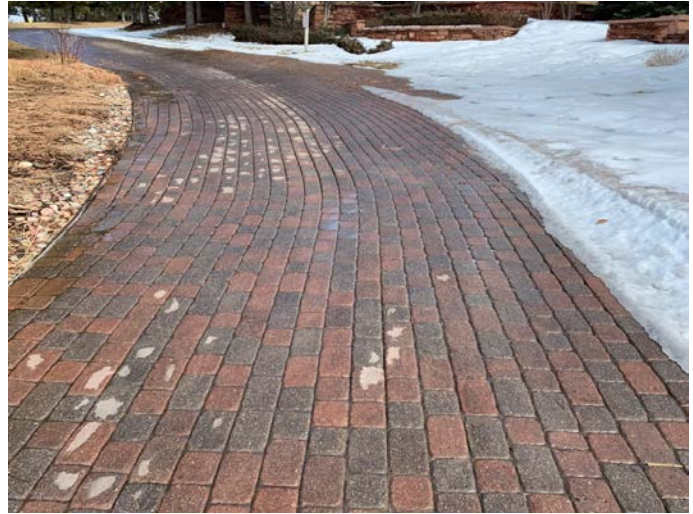
Comp #: 404 Brick Pavers - Repair/Replace

- The paver drive is in good condition at time of observation with no settling noted. Some heaving noted on a few bricks
- It is unlikely that all pavers will fail and require replacement at the same time, therefore, we have recommended an allowance to repair/replace approximately 35% of the area every 10 years.
- As this drive continues to age it may be necessary to increase funding and or frequency of this project.

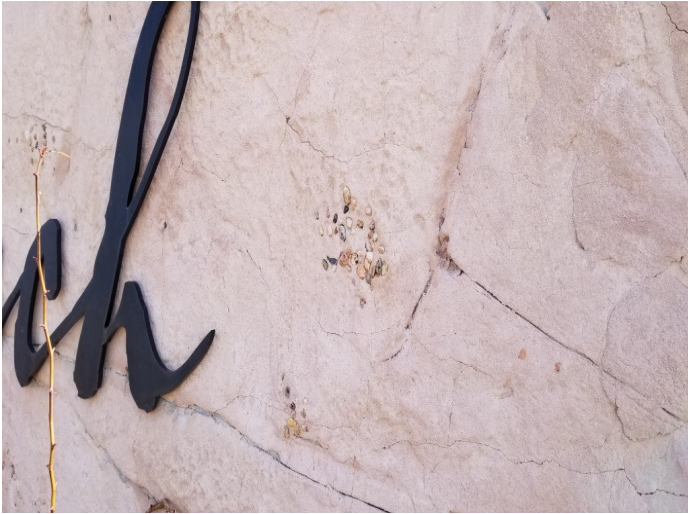
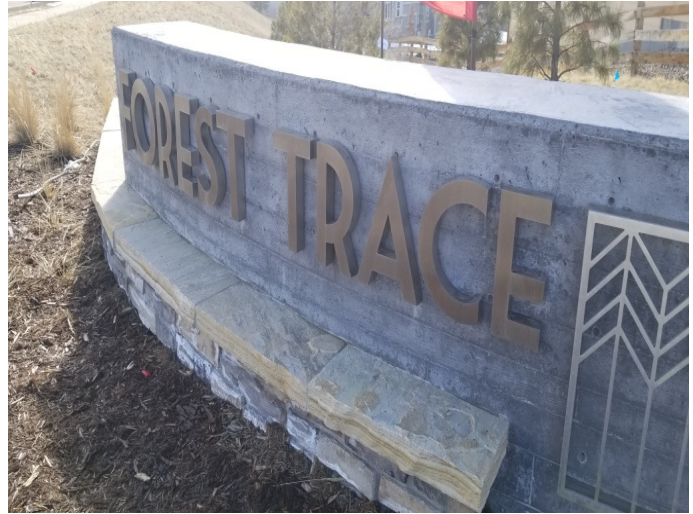
Comp #: 801 Rock Monuments - Minor Refurbishment

- While the materials used should have an indefinite life expectancy, we recommend planning on performing major repairs every 10 - 12 years, with a complete renovation every 20 - 25 years to maintain current trends and an appropriate appearance.
- Depending on the quality of flagstone, in our experience, we have seen some stones delaminate over a period of time, causing the need for replacement.
- Remaining life is based on observed conditions and approximately age of all monuments.

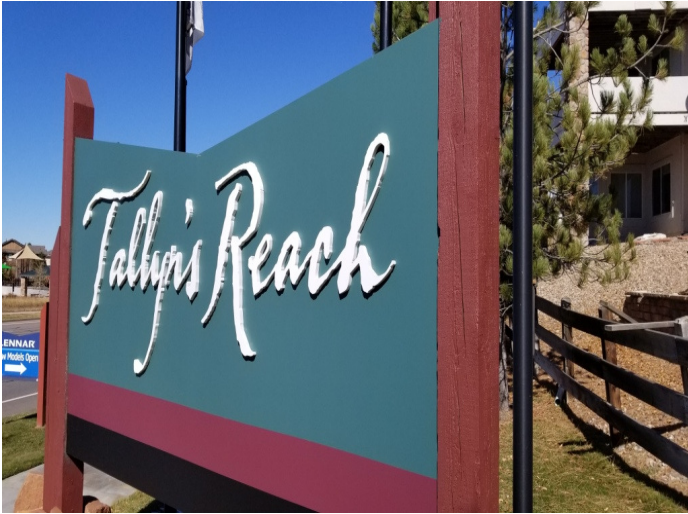
Comp #: 801 Wood Monuments - Minor Refurbishment

- Signs were refurbished in 2019 and are in good condition.
- Reserve an allowance for periodic refurbishment, with no plans to completely replace at this time.
- For major renovation

Allowance for general repairs

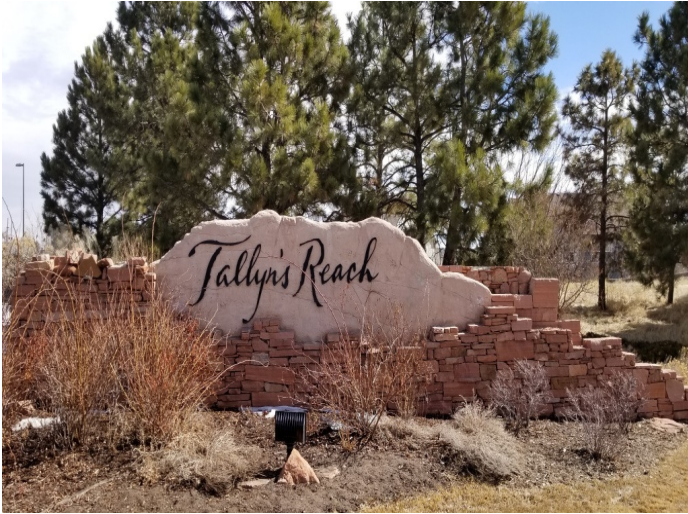
Comp #: 802 Monuments - Major Renovation

- While the materials used should have an indefinite life expectancy, we recommend planning on performing major repairs every 10 - 12 years, with a complete renovation every 20 - 25 years to maintain current trends and an appropriate appearance.
- Depending on the quality of flagstone, in our experience, we have seen some stones delaminate over a period of time, causing the need for replacement.
- Remaining life is based on observed conditions and approximately age of all monuments.
- Add this line item to the "major repair" line item for total renovation costs

Allowance for general repairs

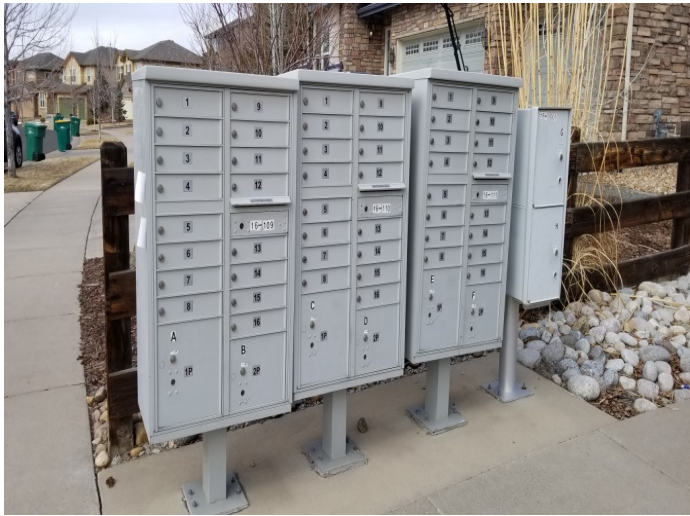
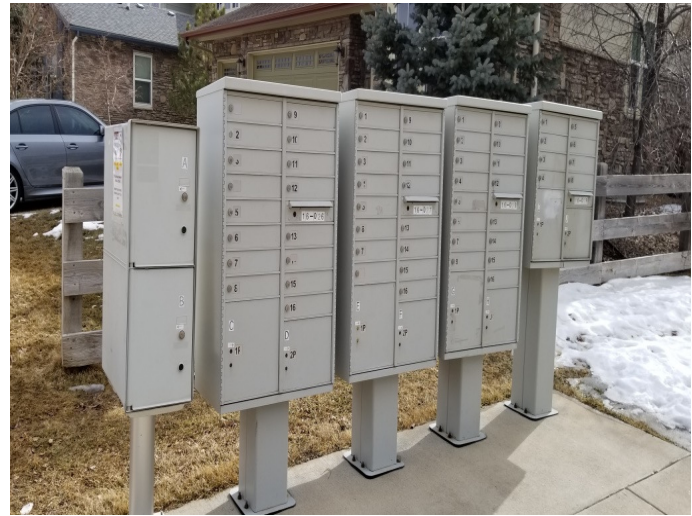
Comp #: 803 Mailboxes - Replace (2006)

- This line item is for the original mailboxes that were installed when construction of the community began.
- Per new Postal regulations effective 2012, "all customers are responsible for repairs and replacement of keys, locks, or the boxes/cluster units themselves".
- Based on our experience, these boxes will have a life expectancy of 15 - 20 years due to location and quality.
- Remaining life is based on age and observed condition.

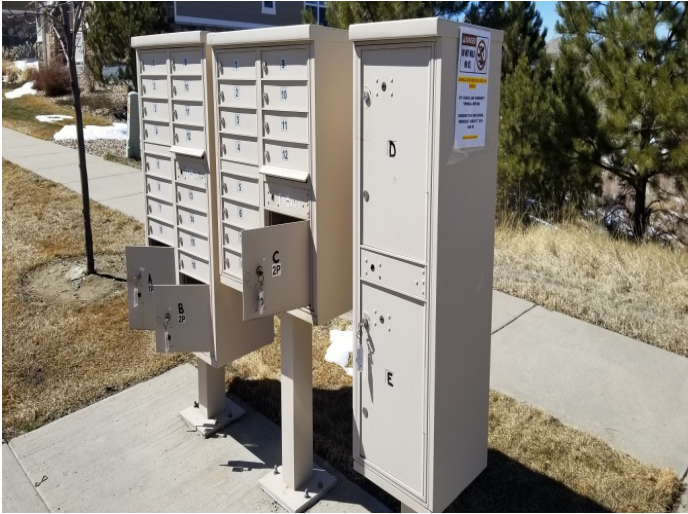
Comp #: 803 Mailboxes - Replace (2010, 2014)

- This line item is for the original mailboxes that were installed in 2010 or 2014. For purposes of this report, we used 2012 as an average age for these mailboxes
- Per new Postal regulations effective 2012, "all customers are responsible for repairs and replacement of keys, locks, or the boxes/cluster units themselves".
- Based on our experience, these boxes will have a life expectancy of 15 - 20 years due to location and quality.
- Remaining life is based on age and observed condition.

Estimate to replace

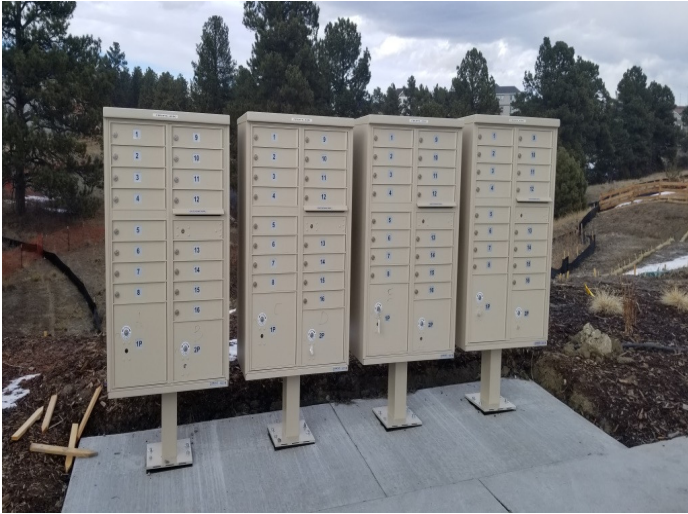
Comp #: 803 Mailboxes - Replace (2016, 2018)

- This line item is for the original mailboxes that were installed in 2016 or 2018. For purposes of this report, we used 2017 as an average age for these mailboxes
- Per new Postal regulations effective 2012, "all customers are responsible for repairs and replacement of keys, locks, or the boxes/cluster units themselves".
- Based on our experience, these boxes will have a life expectancy of 15 - 20 years due to location and quality.
- Remaining life is based on age and observed condition.

Estimate to replace

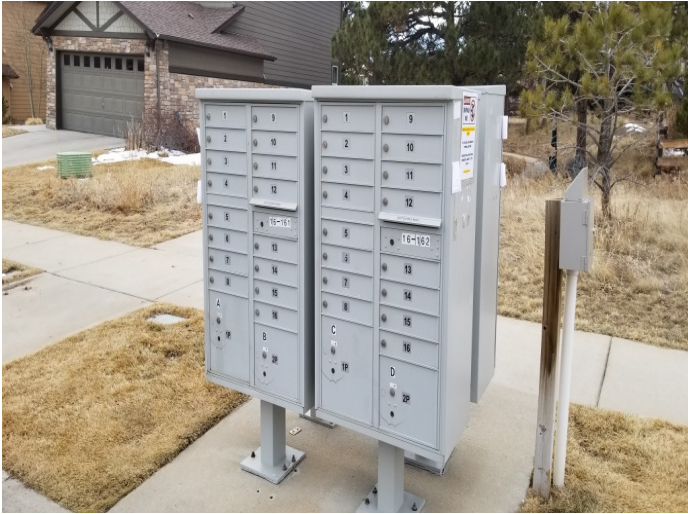
Comp #: 803 Mailboxes - Replace (2005)

- This line item is for the original mailboxes that were installed when construction of the community began.
- Per new Postal regulations effective 2012, "all customers are responsible for repairs and replacement of keys, locks, or the boxes/cluster units themselves".
- Based on our experience, these boxes will have a life expectancy of 15 - 20 years due to location and quality.
- Remaining life is based on age and observed condition.

Estimate to replace

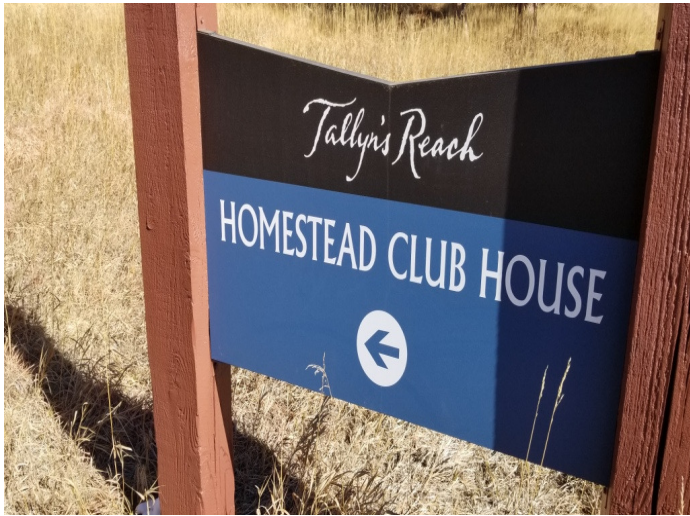
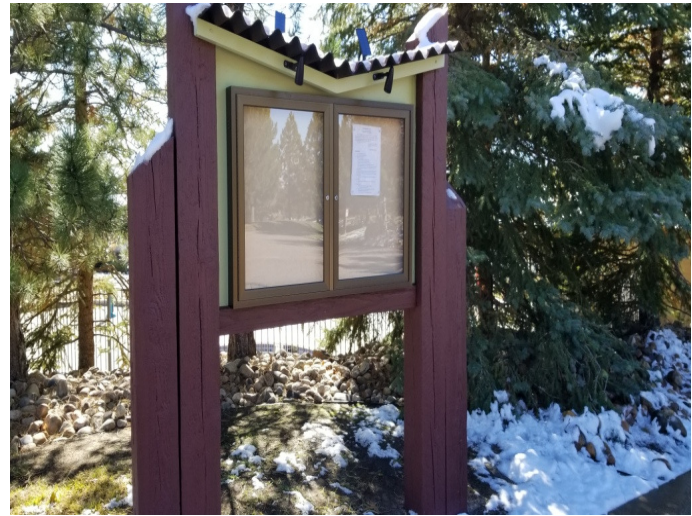
Comp #: 805 Monument Signs (small) - Renovate

- Signs were refurbished in 2019 and are in good condition.
- Sign conditions vary due to location and differing levels of exposure. However, in order to maintain a consistent appearance in the clubhouse/pool area, we recommend replacing all signs at the same time.
- Frequency of repairs or rebuilding will depend on the level of exposure to elements and the quality of products used

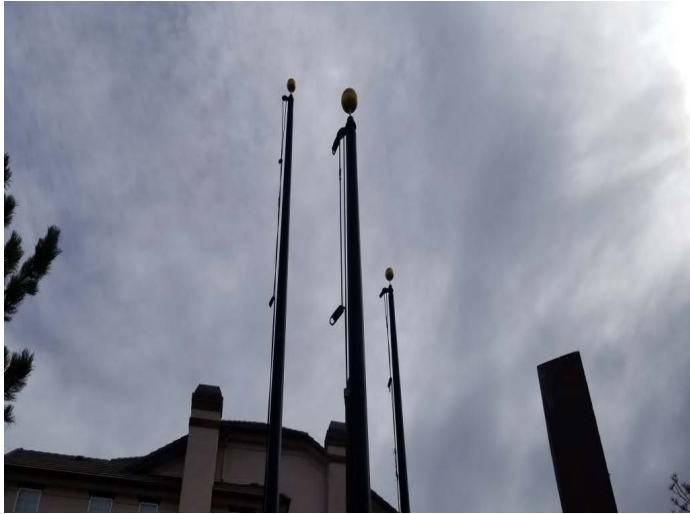
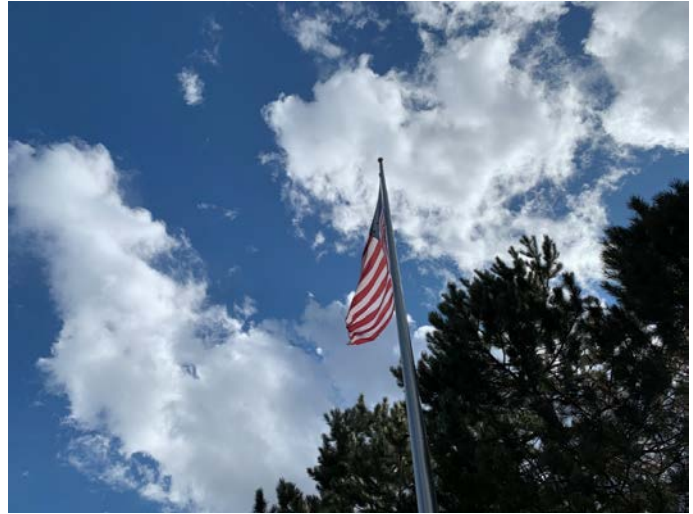
Comp #: 807 Flag Poles - Replace

- Flag poles appeared in good condition with no signs of deterioration noted.
- It is unlikely that the flag poles will fail and require replacement within the scope of this report (30+ years).
- Reserve funding is not necessary for this component at this time.

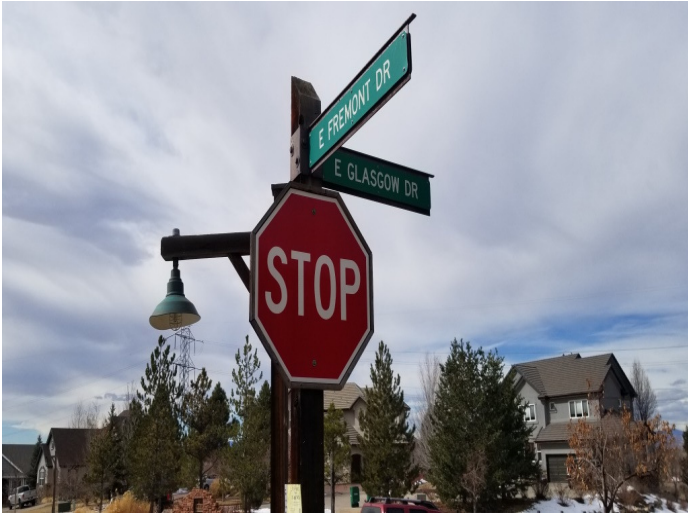
Comp #: 808 Street Signs - Replace

- Conditions vary throughout community. Therefore, we do not recommend reserving to replace all signs at the same time.

- Funding provided below is for replacement of approximately 25% of the community signs every 4 years to maintain a safe and attractive environment.

Estimate to replace 65 signs every 4 years

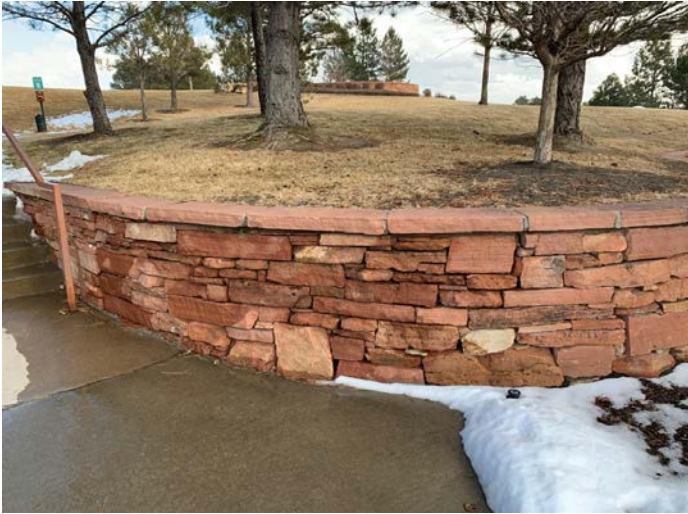
Comp #: 1005 Stone Ret. Wall - Major Repairs

- The funding on this line item is an allowance for wall inspections and necessary repairs resulting from inspections.
- It was recommended in the ;ast Reserve Study that the district engages an engineer or reliable contractor to inspect and maintain the walls every 3 years.
- As the community ages, it may be necessary to adjust cost and or frequency of this project in future reserve study updates.

Allowance for inspections/general repairs

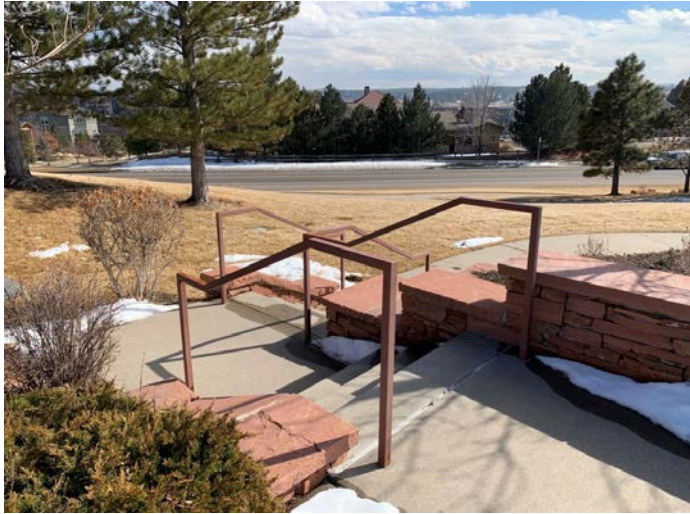
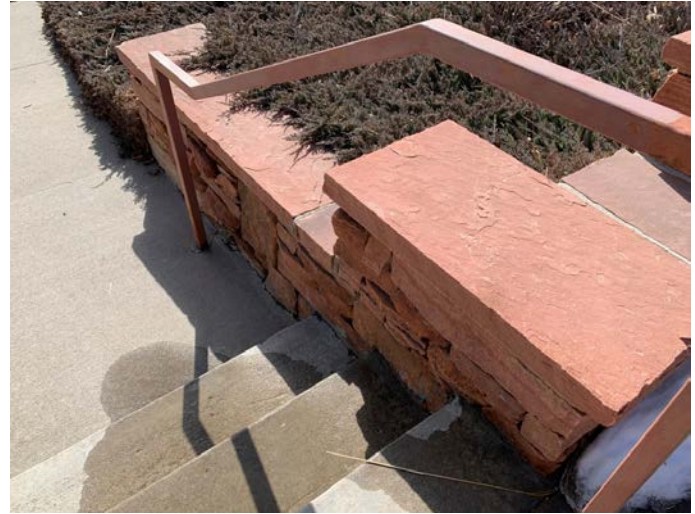
Comp #: 1007 Metal Handrail - Replace

- Reserve to replace exterior handrails every 25 - 30 years.

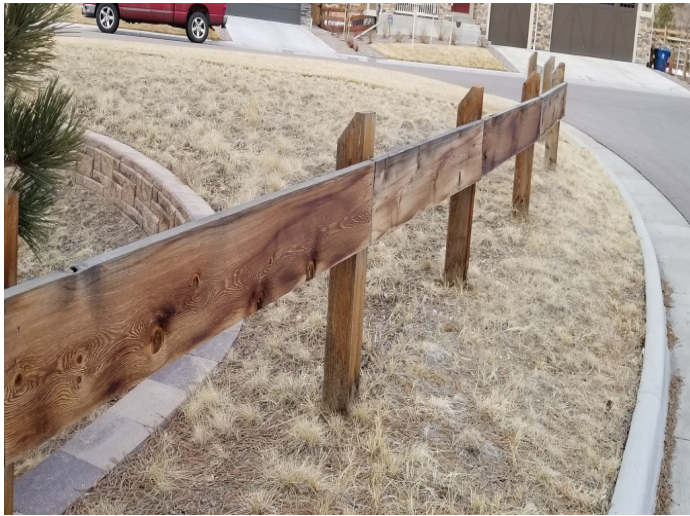
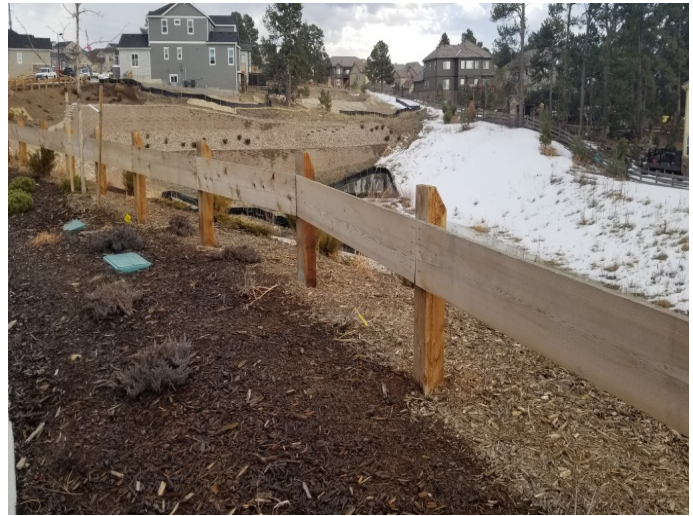
Comp #: 1009 Wood Rail Fencing - Replace

- This type of fence has an average life expectancy of 15 - 20 years, depending on level of maintenance and exposure to elements.

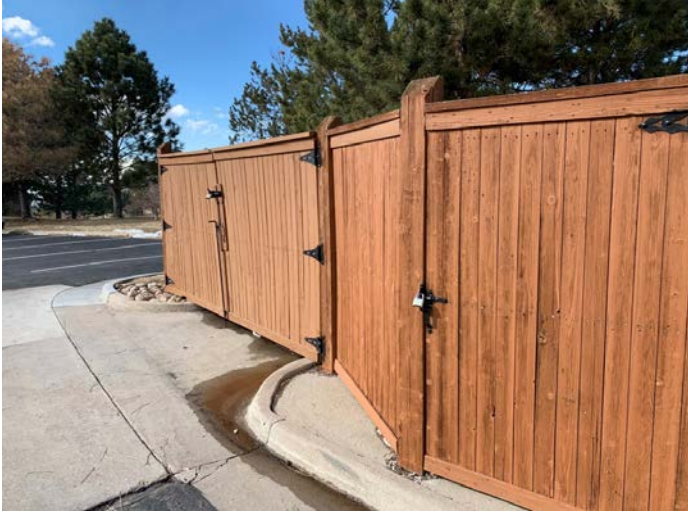
Comp #: 1010 Trash Enclosure - Replace

- Expect frequent repairs and replacement to the gates and possibly the siding due to the exposure to elements and probability of abuse from rubbish companies.
- In our experience, we typically see the need for repairs every 5 - 10 years, depending on the level of abuse.

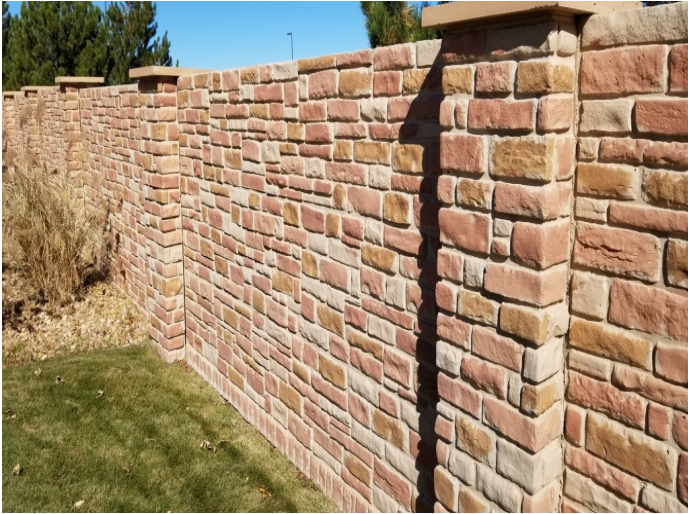
Comp #: 1012 Concrete Perimeter Wall - Major Repairs

- The funding on this line item is for major repairs/partial replacement of the brick privacy wall that runs along E. Smoky Hill Rd at the Northeast perimeter of the property.
- It is unlikely that this wall will fail and require complete replacement, therefore, we recommend reserving for major repairs of the wall every 8 years to ensure proper appearance and safety.

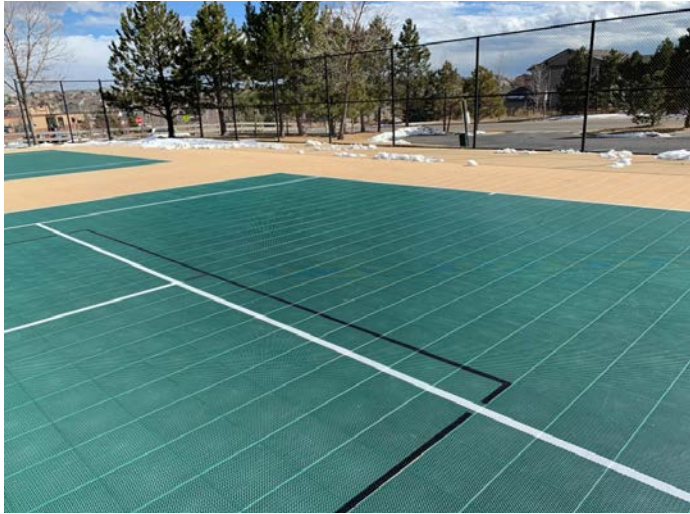
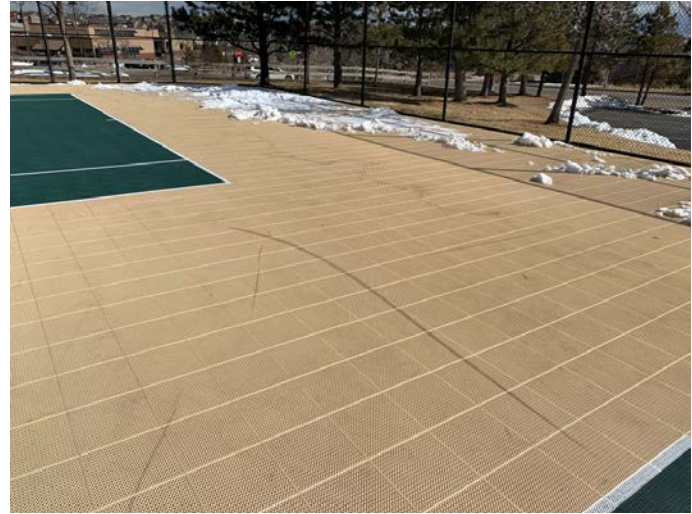
Comp #: 1201 Tennis Court - Replace (Sport Court)

- Sport Court system installed in 2016.
- According to vendor, the average life expectancy ranges from 15 - 20 years.
- Asphalt layer will fail before court will fail. Suggest lifting court and repairing subsurface every 4 - 6 years to ensure maximum life of Sport Court system.

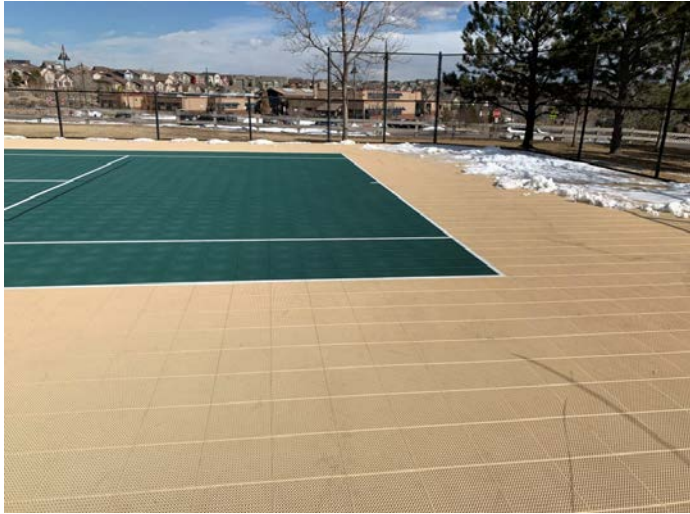
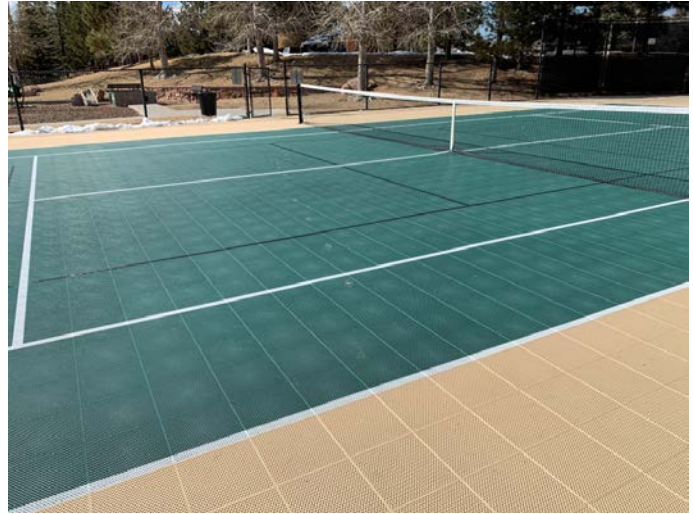
Comp #: 1202 Tennis Court - Subsurface Maintenance

- Recommended to lift the tile surface, repair the subsurface (crack fill, etc.), and relay tiles every 4 - 5 years
- Remaining life is based on age of system.

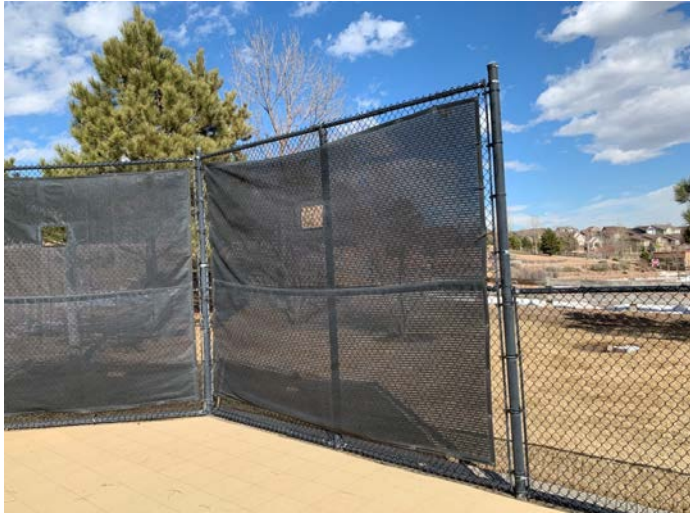
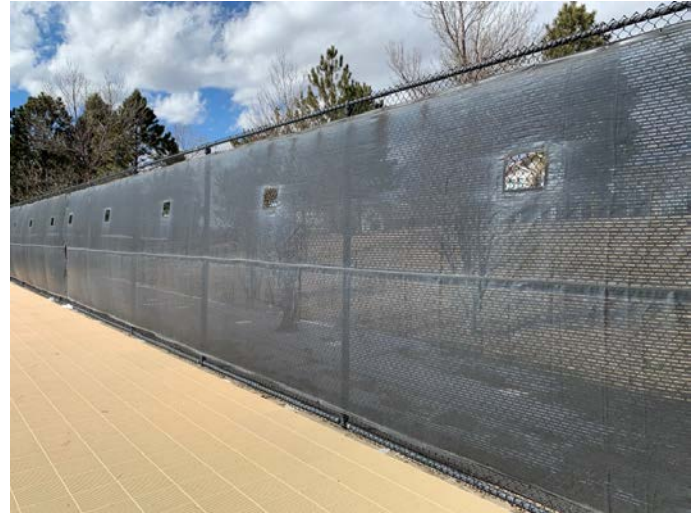
Comp #: 1203 Tennis Court Windscreen - Replace

- As long as the windscreen is removed and stored during Winter months, we expect the material to have a useful life of approximately 6 - 8 years in this environment.

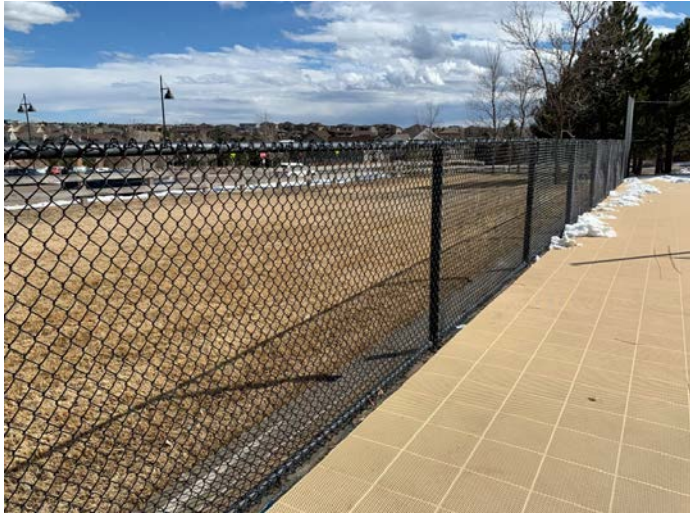
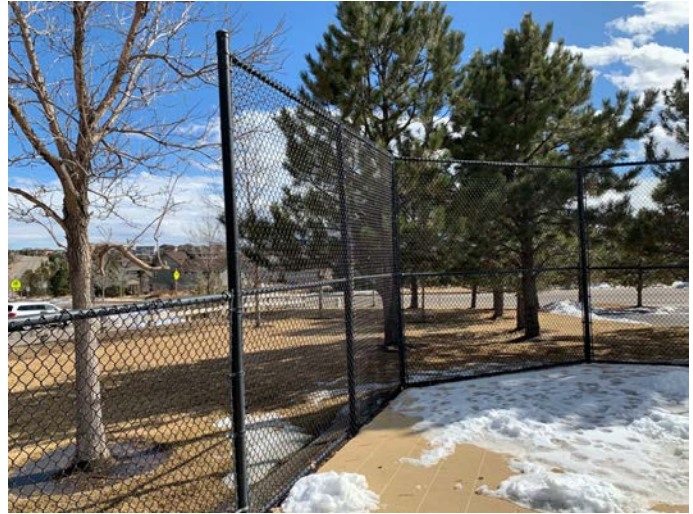
Comp #: 1204 Chain Link Fence - Replace

- Average life of tennis court fencing ranges from 30 - 40 years, depending on level of use and abuse.
- Fence appears to be in a fair condition, but adjust the remaining life a few years so the replacement is coordinated with future court replacement

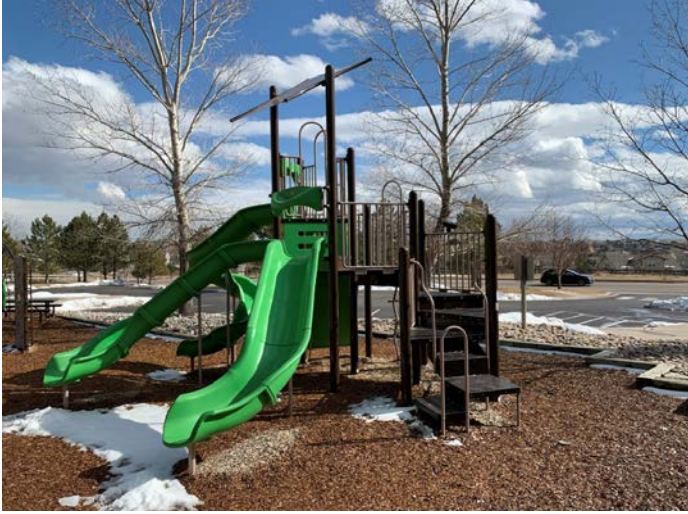
Comp #: 1301 Play Equipment - Replace

- Depending on overall level of use and care, the average life expectancy for play equipment ranges from 15 - 18 years.
- Expect high use for this facility due to the demographics of the community with the majority being young families with children.
- Manufacturer of equipment is "Burke".

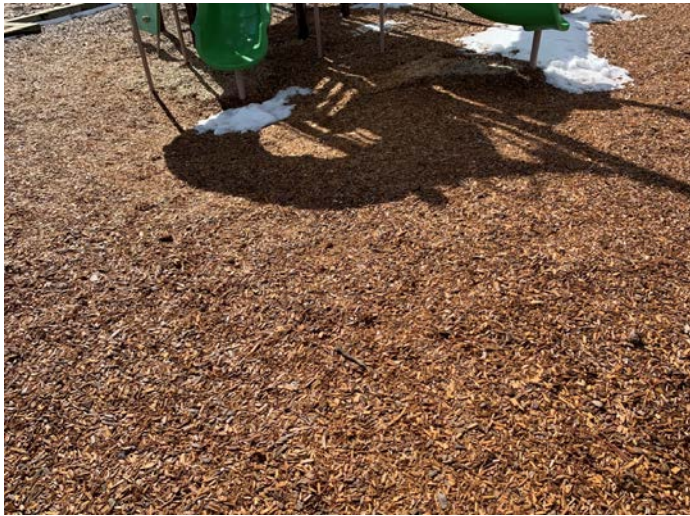
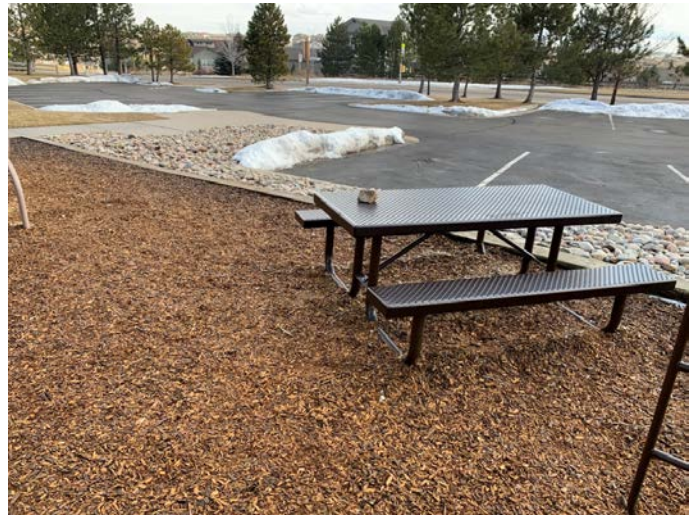
Comp #: 1303 Tot Lot Groundcover - Refill

- Depending on the level of use and care, expect to refill groundcover bed every 3 to 4 years to maintain appearance and ensure proper function as a safety component.

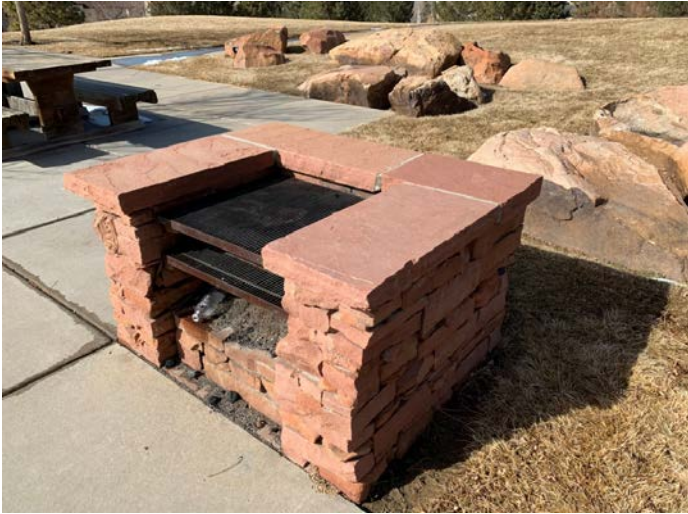
Comp #: 1305 Barbecue - Replace

- This grill is a built-in charcoal unit with no moving parts, as such, it is unlikely that the entire piece will require replacement.
- Replace grills and charcoal pans on an as needed basis using operating funds, no reserve funding necessary.

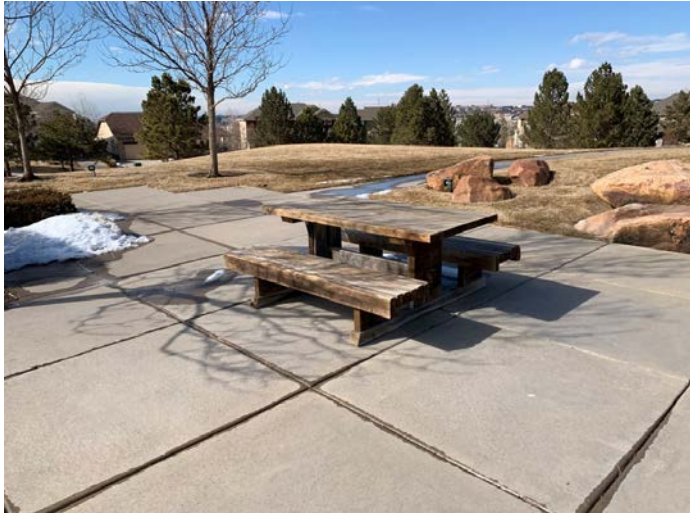
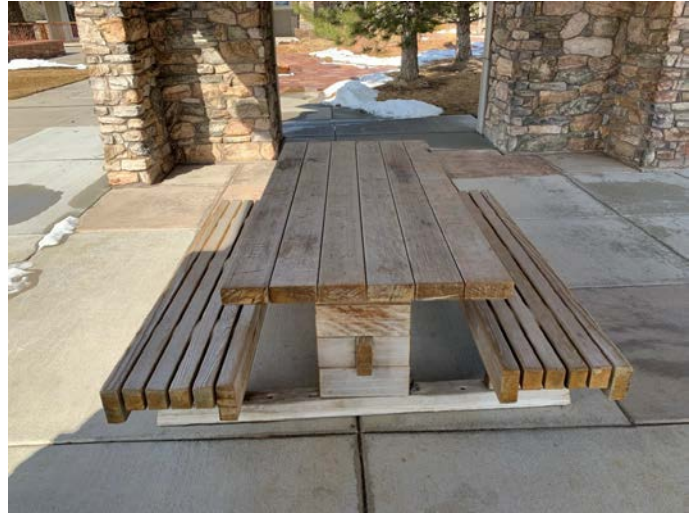
Comp #: 1306 Picnic Tables - Replace

- We are recommending replacement of the picnic tables due to the aesthetics of the area, the picnic tables are dated in appearance.
- We recommend reserving to replace picnic tables every 10 - 12 years to ensure a safe and attractive appearance.

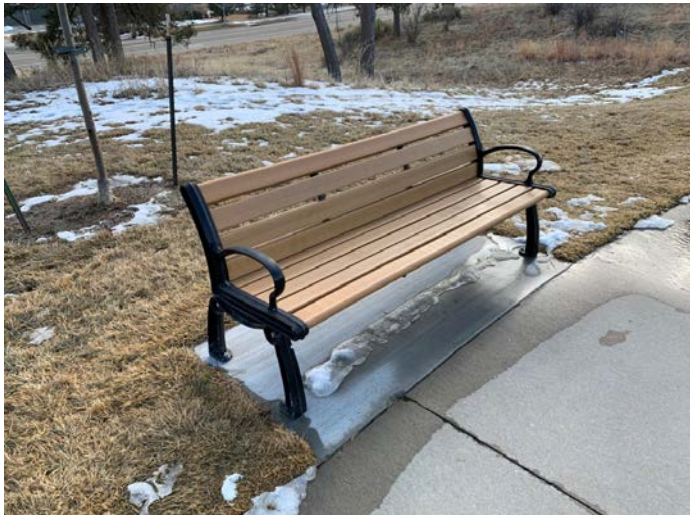
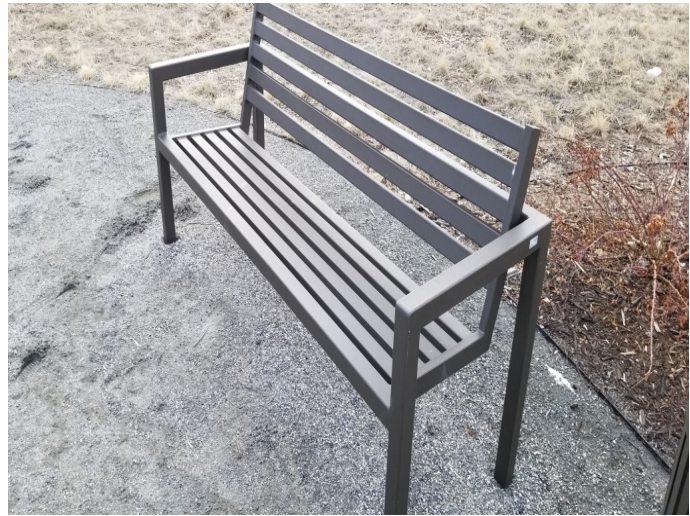
Comp #: 1307 Site Furnishings - Replace

- The average life expectancy for this type of furniture generally ranges between 10 - 15 years, depending on quality and levels of use and care.
- The remaining life is based on the average age of all furnishings.

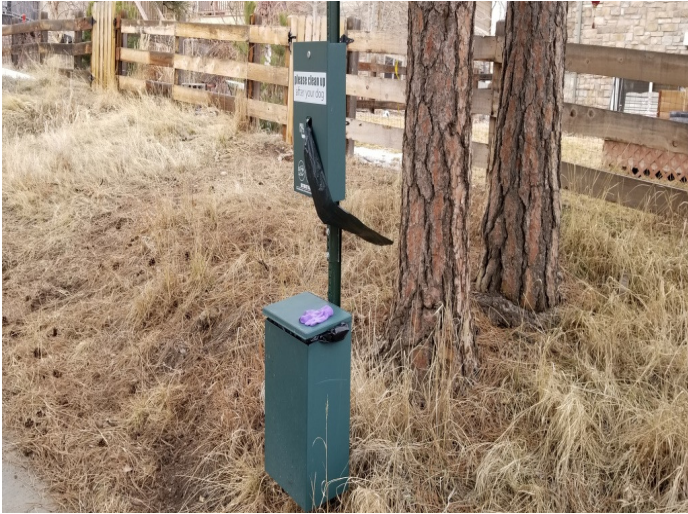
Comp #: 1311 Pet Waste Pick Up Stations - Replace

- Due to the varying ages of stations and low individual replacement cost of each station, it is an unlikely event that all will require replacement at the same time
- Therefore, we do not recommend reserving for replacement at this time.
- Maintain and replace on an as needed basis using operating funds.

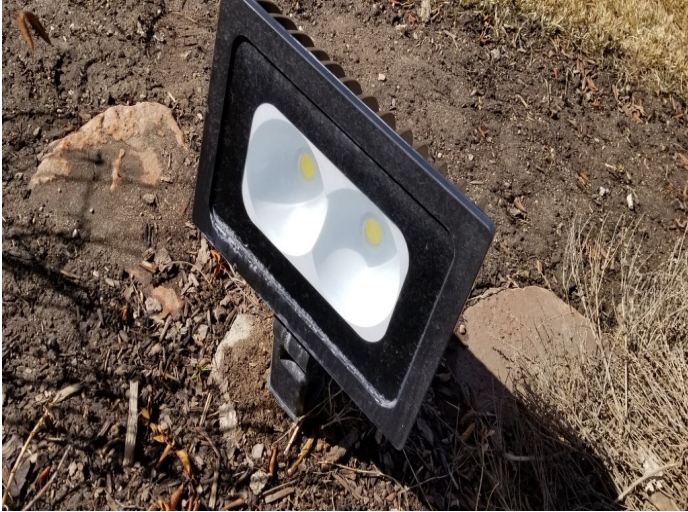
Comp #: 1603 Landscape Lights - Replace

- Due to the quantity of lights throughout the community, we recommend establishing an allowance for periodic partial replacement of lights that are needed every 6 years.
- Remaining life is based on the observation of numerous LED lights present and the assumption that some were replaced recently.

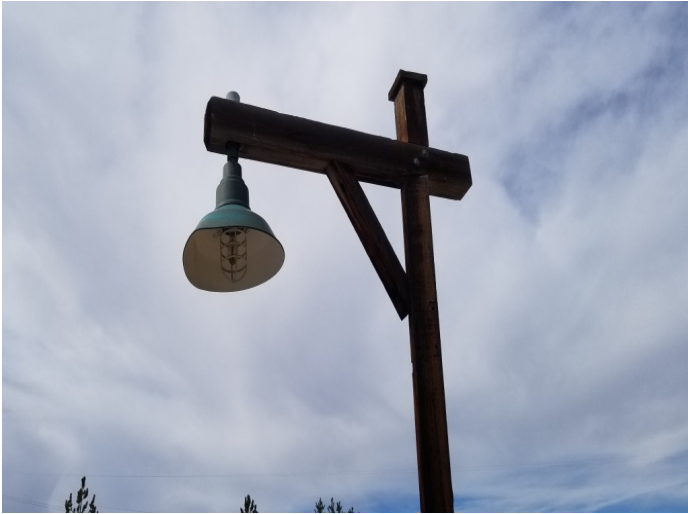
Comp #: 1609 Street Lights - Partial Replace

- The average replacement cycle for this type of light ranges between 25 - 30 years.
- Due to the quantity of lights and the varying ages, we recommend Reserving an allowance for partial replacement every 5 years.
- Continue to monitor deterioration rates and adjust accordingly in future updates.

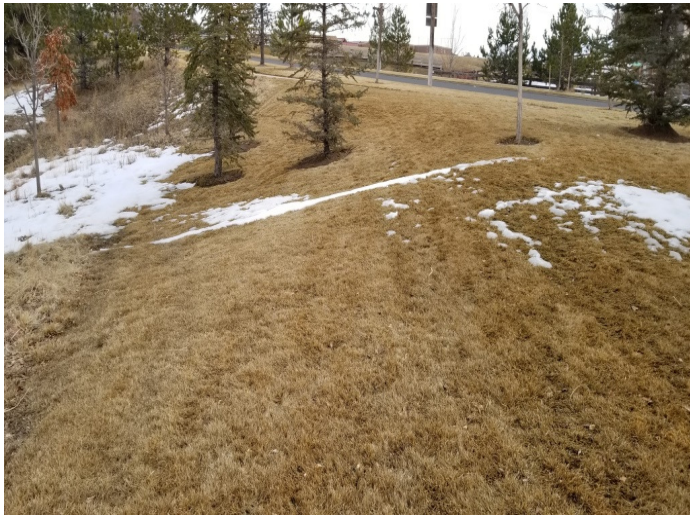
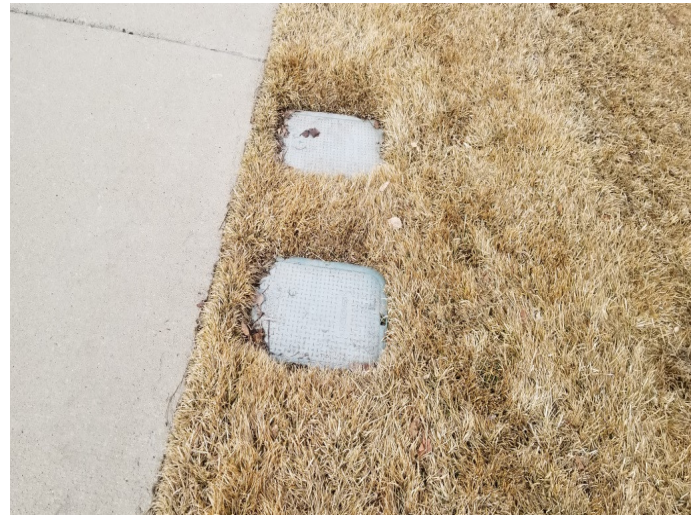
Comp #: 1701 Irrigation System - Replace

- information retained from past Reserve Study
- This line item is for complete replacement of the irrigation system every 30 years to ensure proper function and water conservation efforts.
- Norris Designs recommends a life expectancy of 30 years on the entire system and assumes the overall age of the system is approximately 16 years.
- Reserve to replace the irrigation system every 25 - 30 years.
- Add the costs reported below to the costs reported on component #1703 for total irrigation system replacement.
