Level 2, Premium Reserve Analysis

Tallyn's Reach Metro District

24900 E. Park Crescent Dr.
Aurora, CO. 80016

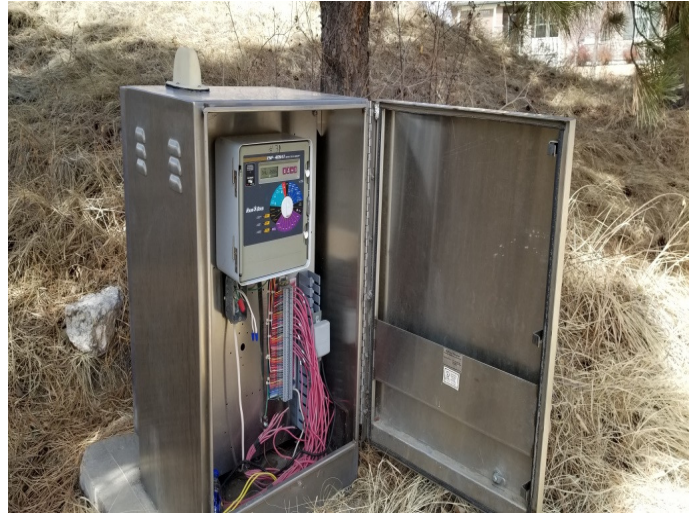
Comp #: 1703 Irrigation Controllers - Replace

- In order to conserve water and increase the effectiveness of the irrigation system, Norris Design recommends a complete overhaul of the irrigation system's controls.
- The timeline for this project comes at approximately 1/2 the life of the system, therefore, we recommend reserving to update the system with new technology every 12 - 15 years to ensure maximum conservation and effectiveness of the system.
- The costs reported on this line item are subtracted from the costs of the total irrigation replacement line item (#1701) to reflect actual.

NOTE - Despite past recommendation from Norris design, controllers we observed in 2018/2019 remained the same. Therefore, keep RUL at '0' at this time.

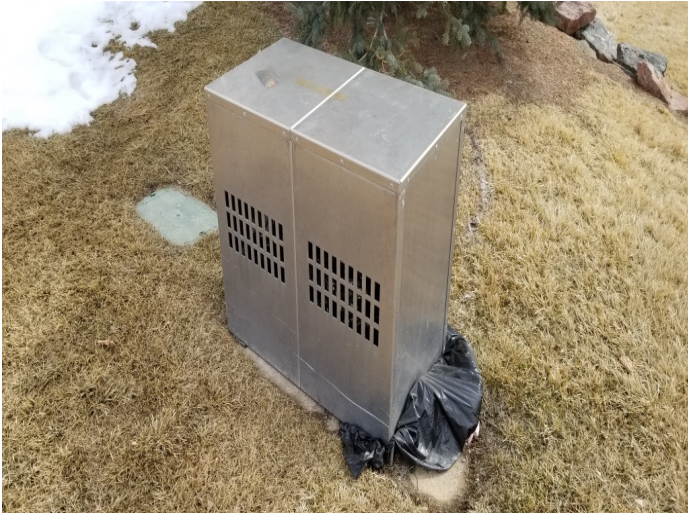
Comp #: 1704 Backflow Enclosures - Replace

- The types of enclosures are coated steel cages, which have a small replacement cost (approximately \$400 each + install). Stainless steel enclosures have a long life expectancy under normal conditions.
- Due to a low cost, we suggest treating replacement on an as needed basis with general operating funds.

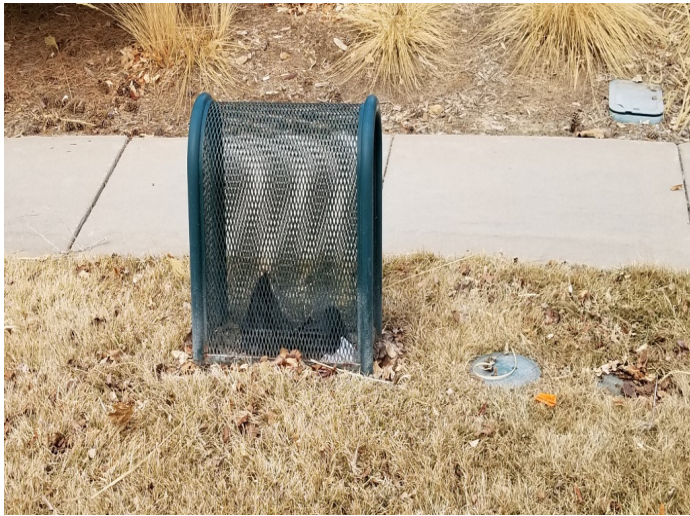
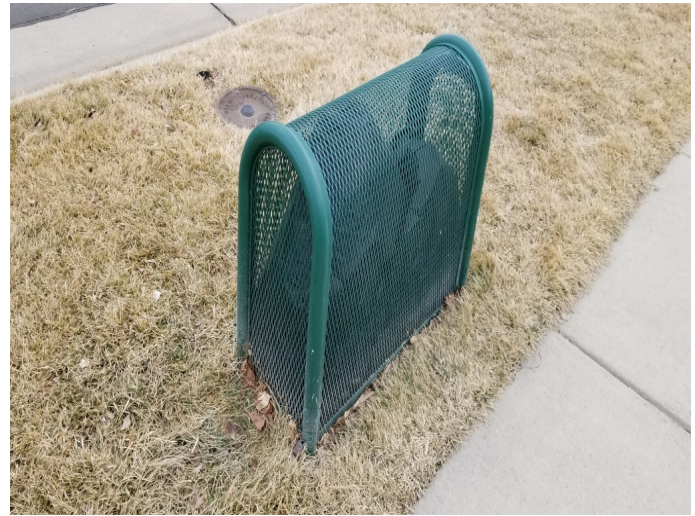
Comp #: 1706 Backflow Devices - Replace

- Due to the ability to rebuild and replace these devices for a relatively low cost and the fact that failure of the device is unpredictable, we do not recommend reserving for replacement.
- Repair and/or replace these devices on an as needed basis using operating funds.

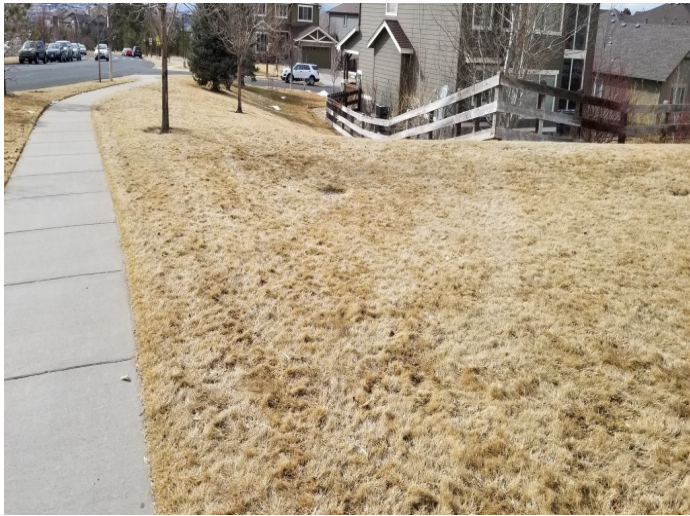
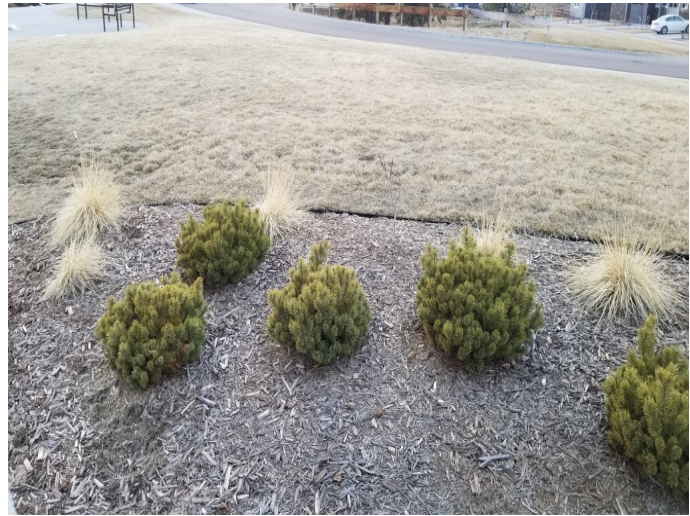
Comp #: 1801 Landscaping - Replace

- information retained from past Reserve Study
- This line item is for landscaping replacement/refurbishment scheduled to occur simultaneously with component #1701 (irrigation system replacement) every 30 years.
- Norris Design reported that the landscaping cost at the time of irrigation system replacement will be approximately 75% of the cost of the irrigation system replacement project.
- Additionally, we have provided a cyclical allowance for general/local refurbishment every 5 years on component #1805, costs reported on component #1805 should be added to the costs on this line item for actual.

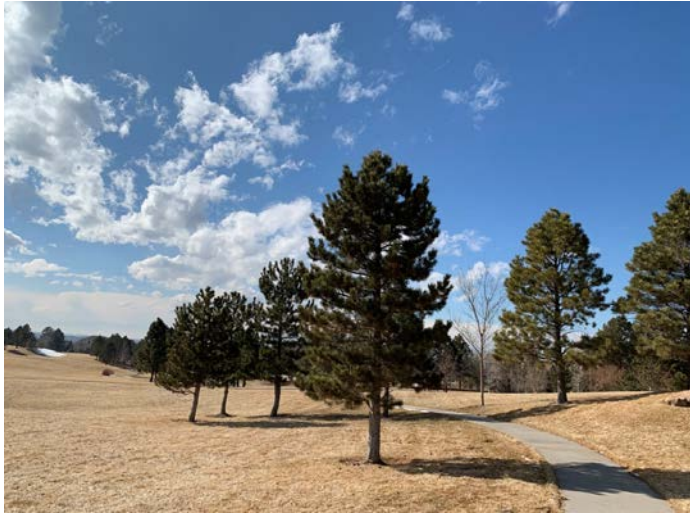
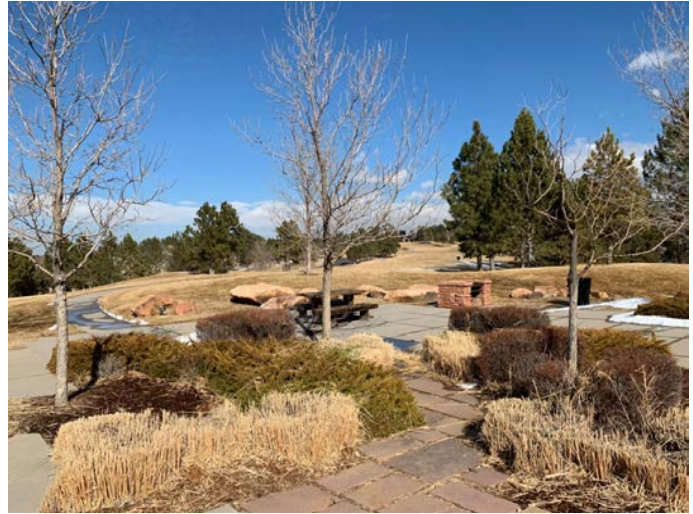
Comp #: 1804 Tree - Maintenance/Replacement

- This line item is for ongoing, cyclical maintenance and replacement of trees throughout the metro district.
- Norris Designs recommends reserving approximately \$28,000/year for cyclical tree replacement and maintenance, however, due to industry restrictions, we cannot recommend reserving for annual expenses, therefore, we have provided an allowance for major maintenance and replacement every 3 years.

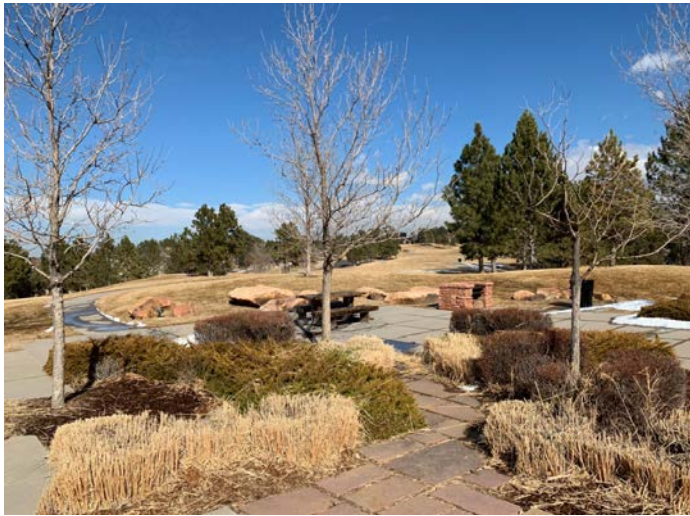
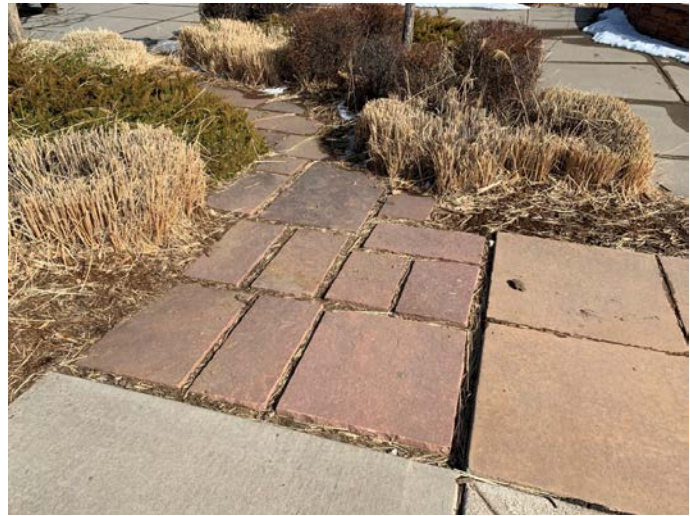
Comp #: 1805 Landscaping - Periodic Refurbish

- This line item is for projects that lie outside the scope of routine maintenance.
- In order to preserve an attractive curb appeal and to maintain the health of the plants and shrubs, we recommend reserving for refurbishment projects every 4 - 5 years.
- This line item is for cyclical refurbishment and should not be considered as complete landscaping replacement.
- Add the costs on this line item to costs on component #1801 for total landscape replacement costs.

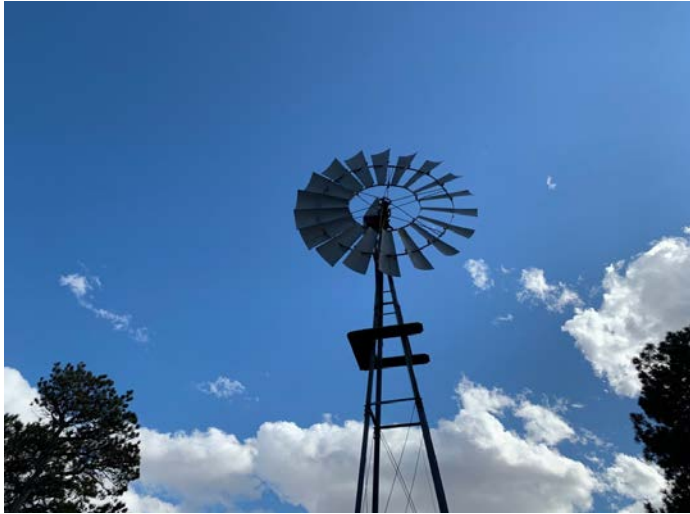
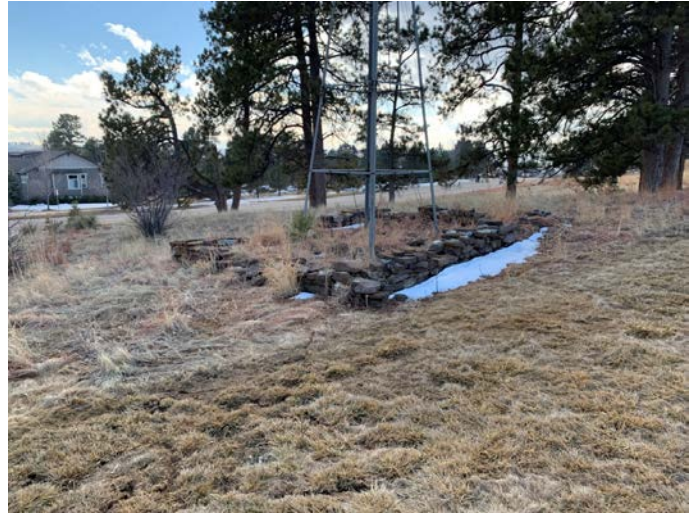
Comp #: 2005 Windmill - Major Repairs

- Since this is a decorative asset and no components are relying on its proper function, we do not recommend reserving a large allowance for rebuilding or replacing this windmill.
- Reserve a small allowance to ensure proper safety and appearance every 3 years.
